Burlington County | River Route Corridor Study

INTRODUCTION

This final report summarizes priority locations (intersections and corridors) along the River Route Corridor, stretching from Cinnaminson to Bordentown City and Township. A total of 41 locations are included. For each location, the report includes summaries of existing conditions (location, current design and geometric configuration, crash data, traffic volumes, and local and regional context), notable previous studies and findings, issues and deficiencies, recommended improvements, and concept diagrams.

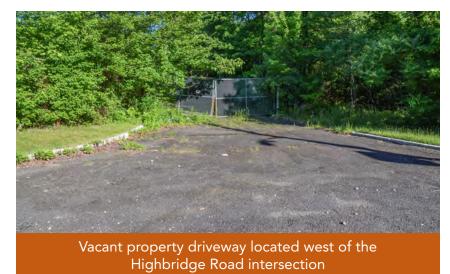
Limited visibility, lack of deceleration lanes, and poor advance signage at the intersection

- Add a dedicated right-turn lane to northbound U.S. 130 for rightturns to Highbridge Road.
- Add directional signs from Hogback Road to encourage alternate

routes through Ward Avenue and Livingston Lane to U.S. 130 through a signalized intersection, especially if signalization at Highbridge Road is not a possibility.

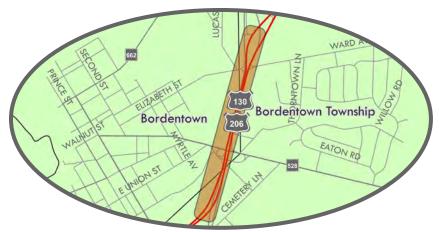
- Frequent driveways and access points along the corridor cause unsafe driver behavior, reduce sight distances and introduce unnecessary conflict points with large speed differentials
- Crash rates are higher along the corridor than the state average for similar cross-sections

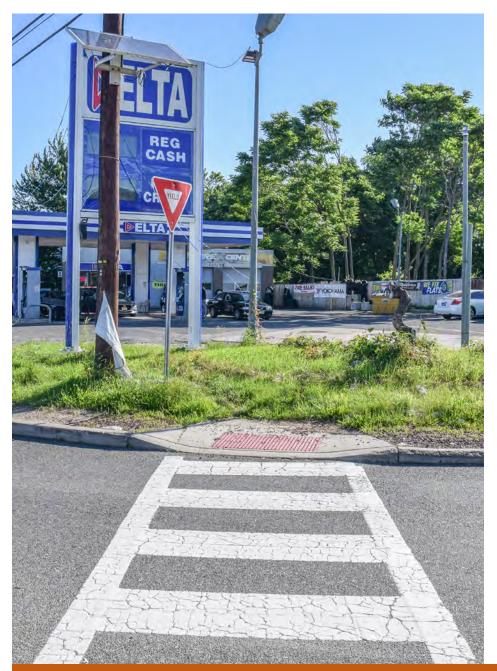
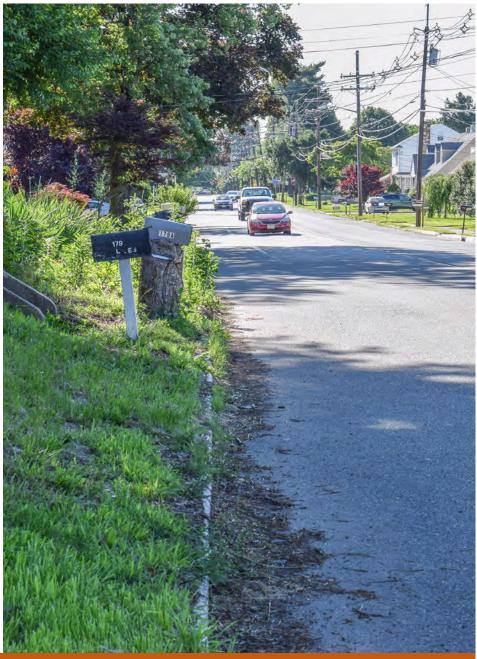
Incomplete pedestrian network at intersection and along approach roadways reduces pedestrian mobility across U.S. 130/206

- Replace the eastbound sidewalk along Crosswicks Street with a wider, bi-directional multi-use path to accommodate bicyclists and pedestrians. All bicyclists will use the proposed path to cross U.S. 130/206 in either direction. Bicyclists making the eastbound crossing will be routed along the proposed path across the intersection, with shared-lane markings guiding them further east. All westbound bicyclists will cross Crosswicks Street at the intersection adjacent to the existing pedestrian crosswalks, then continue along the proposed path until crossing to the westbound side again using the proposed crosswalk at Gilder Park Road.

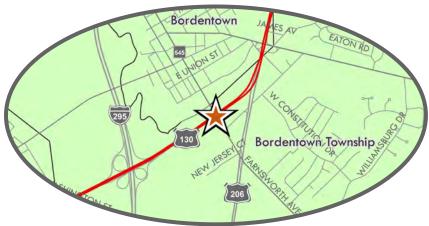
Driveway encroachment is evident along southbound U.S. 130 just north of the intersection.

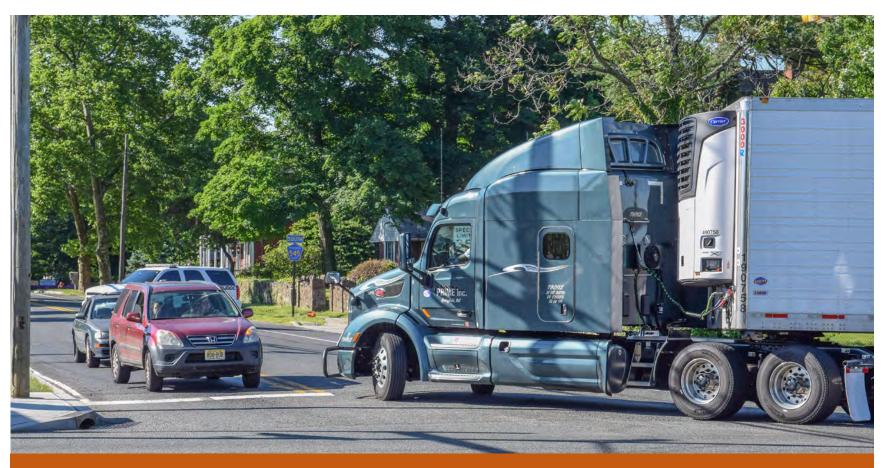
Right-turning trucks from northbound U.S. 130 to eastbound Farnsworth Avenue have limited space due to a tight curb radius

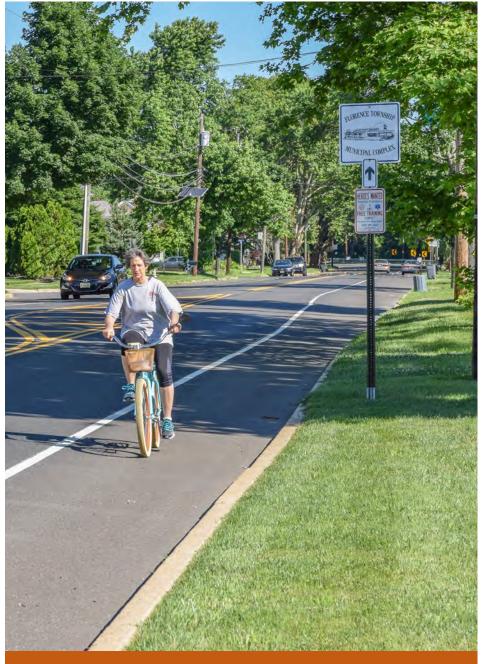
Delaware Avenue is a prime candidate for bicycle lanes

- Fill in the sidewalk gap at the intersection and along both associated roadways to connect residential areas with schools and local businesses.
- Stripe bicycle lanes along Delaware Avenue from Florence Township Riverfront School to the intersection by utilizing the existing shoulder space.
- Install pedestrian crossing lights for all legs of the intersection to improve driver visibility.
- Stripe shared lane markings along Hornberger Avenue between the intersection and the Roebling River Line Station to encourage bicycling throughout the neighborhood.
- Stripe all missing crosswalks at the intersection.

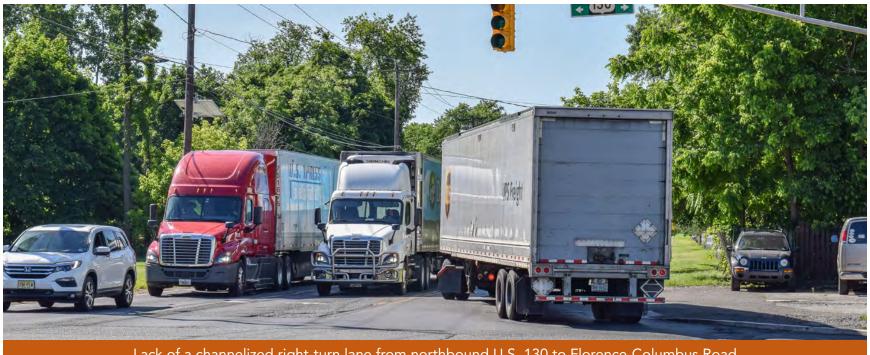
Lack of a channelized right-turn lane from northbound U.S. 130 to Florence-Columbus Road results in truck congestion at the intersection

- 130 alongside the new jug-handle.
- Provide double left-lanes and a through lane from the northbound approach of Florence-Columbus Road.
- Provide double left-lanes from southbound U.S. 130 to southbound Florence-Columbus Road.
- Construct a channelized right-turn lane from northbound U.S. 130 to southbound Florence-Columbus Road.
- Investigate the future addition of a dedicated right-turn lane to southbound U.S. 130 from Delaware Avenue to improve circulation at the intersection. This may require additional right-of-way acquisition.
- Extend the right-turn lane leading to the proposed channelized rightturn lane to accommodate all turning vehicles.
- Improve overall geometry of curb returns at the intersection.
- Improve pedestrian facilities between adjacent residential developments and commercial establishments at the intersection, including sidewalks, crosswalks and ADA curb ramps.
